Rotary Racer's Roll

Castle Combe – 2010-06-27

The Rotary Racer Team

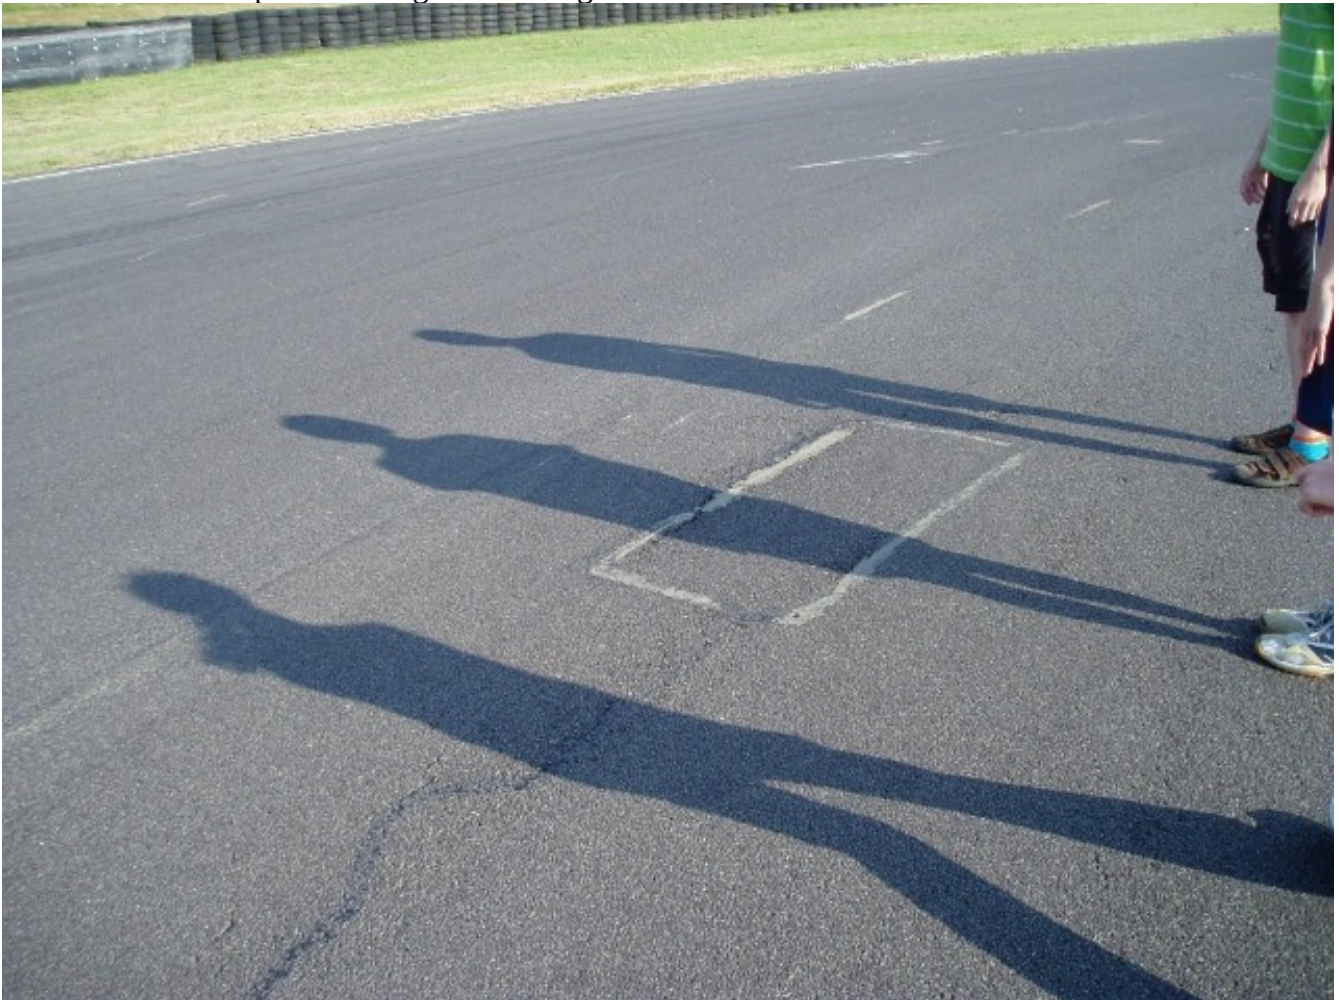
- We think the car was cornering hard and the rear end was sliding a touch when it hit the ridge. We think that this lifted the rear end slightly off the ground, allowing the car to rotate, possibly with the brakes on. When the car dropped down the wheel would have increased sideways friction. We think this gave enough sideways force for the car to topple. Alternatively hitting the ridge may have caused the problem, but the driver did say that the car bumped up and down on the rear end before starting to roll.

- There were no flats on the front tyres suggesting that, although the brakes were on, the front wheels had not locked up.
- We believe the car rolled twice before sliding to a halt. The roll-bar protected the driver admirably and the foam sides probably softened the landing and the friction probably brought the car to a halt relatively quickly.

- The driver was un-harmed by the accident, with just a few very minor bruises. His helmet was untouched apart from slight scratching on the left hand end of the visor.

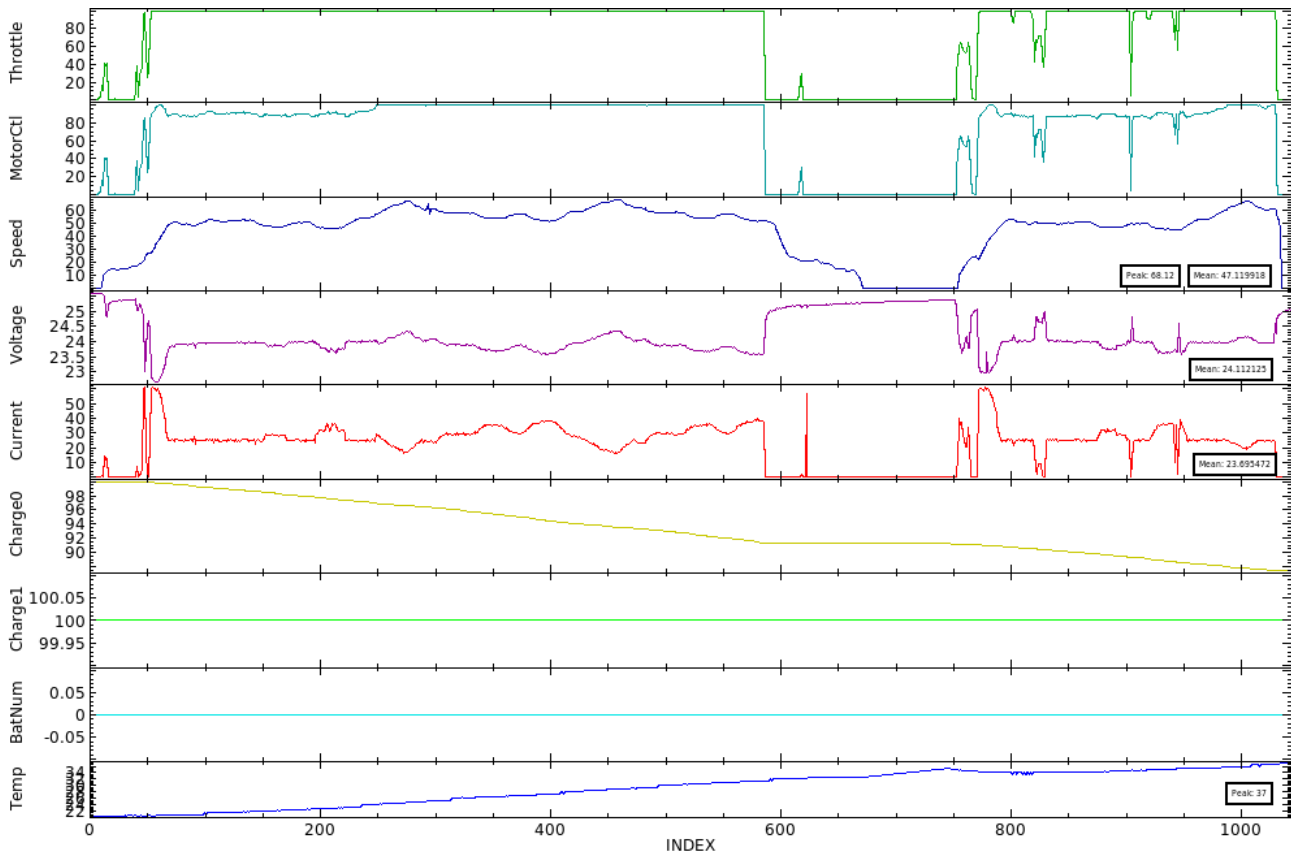
Data Logs

- The car was going reasonably fast, but not excessively so, at about 36.9MPH after the downhill section of the track with the wind behind. The car slowed down as it travelled up the hill towards Quarry corner and then started cornering. From the data logs it looks like the driver started to slow the car down further, with the brakes, in the last few seconds and it appears to have rolled while doing between 27.8MPH and 32.5MPH. The car had gone through this section with a previous driver at 36MPH and 37.7MPH previously on the day while on full power. However, this is quite fast for the sharp corner, a good racing line would be needed.

The car was logging data during the practice runs. This includes: Throttle position, Motor power level, Speed, Voltage, Current, GPS position etc. The data for this is at:

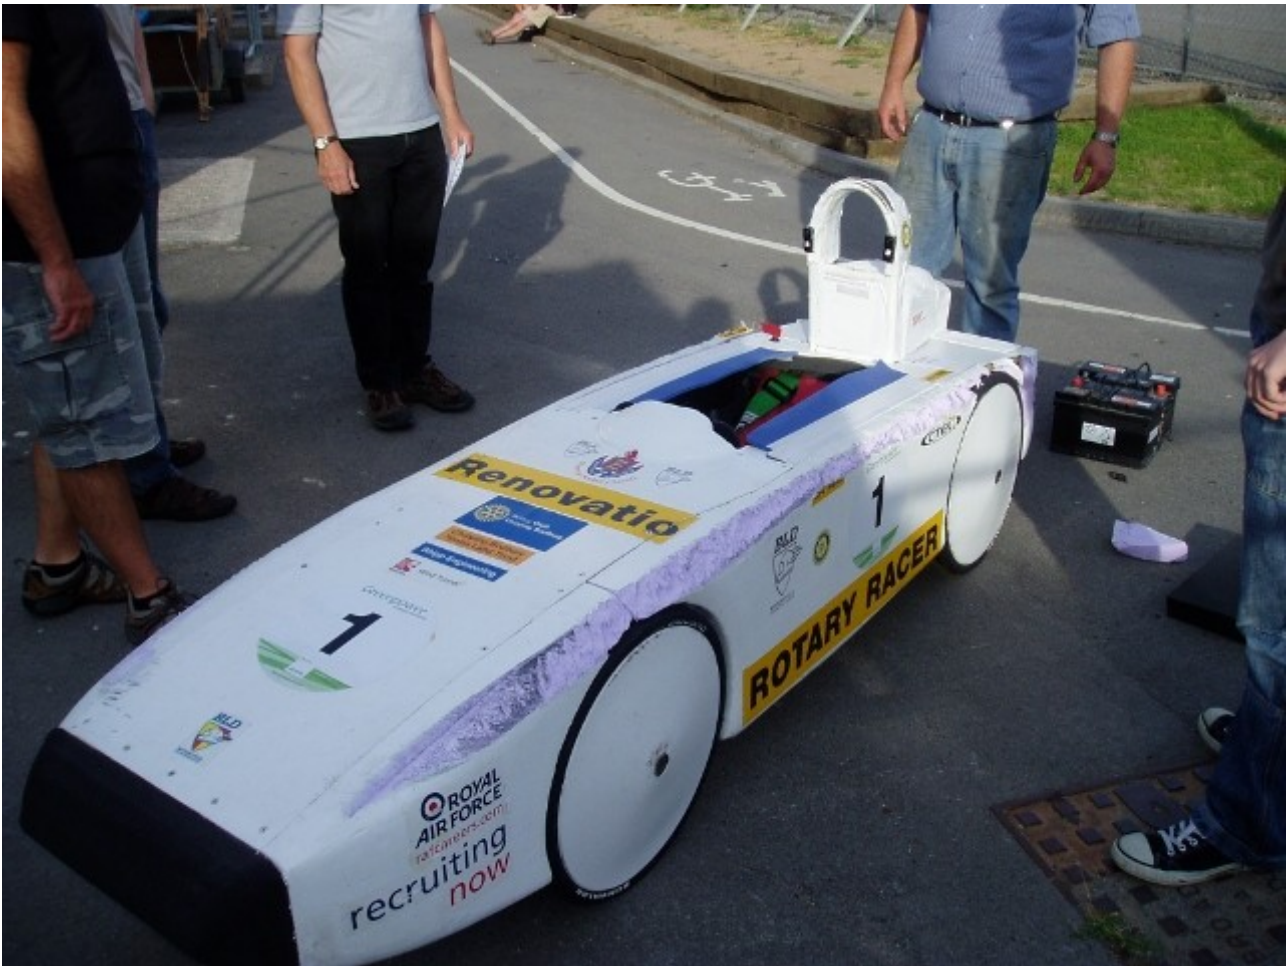
- The roll-bar was completely intact and fully upright. It had bent “forward” about an inch at the top, the car must have gone backwards for a bit, was bend slightly to one side and had deep scoring on the top edge where it had hit and rubbed the ground. The roll-bar was made of 25.4mm steel tubing, 1.6mm thick. It had a horizontal, welded steel tube brace about 190mm from the top. It was mounted to the cars steel sub-frame at the bottom by welded spigots and with 8mm steel bolts about 150mm up from this. It had an aluminium rear strut going to the rear chassis. This was fastened to the roll-bar with bolted plastic bungs one of which had popped out with the roll-bar going forward.

- The right-hand side rear wheel had bucked badly. We are pretty sure this happened during the roll rather than before. There are no broken spokes and the hubs are intact. The rim is bent. The wheels are quite strong and other than the buckle in the rim look fine. This wheel is the free running, not motor driven, wheel and was the wheel on the inside of the corner.

- The tyres, Schwalbe Durano's, were in good condition. They have done about 500 miles or so, but had no flat spots or other damage. There are some sideways scuff marks on the rear tyres after this race, but they were still fully inflated (about 110 PSI) and generally un-damaged apart from some scuffing.

- The top corners of the cars foam sides are worn away. We think this would have softened the roll and brought the car to a timely stop due to the friction with the road surface.

1. We will replace the 20 inch wheels with 16 inch wheels. This will lower the cars centre of gravity by about 30mm and improve roll stability by about 12%.
2. We will make the dish in the wheels flatter. This will increase the track of the wheels by about 20mm (3%).
3. We will replace the roll-bar with an identical remade one, as it has been used.
4. We will change the rear strut to be able to take both push and pull forces.
5. We will spend more time with the drivers going over the circuits and its corners before races.
6. We intend to take the drivers on a go-kart circuit to better hone their drivers skills.

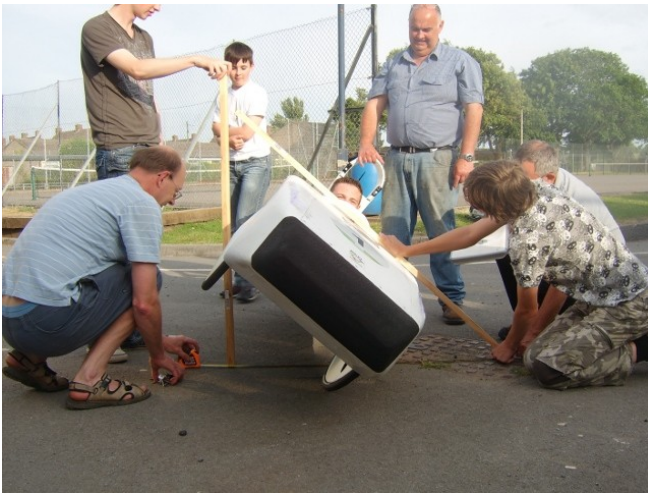
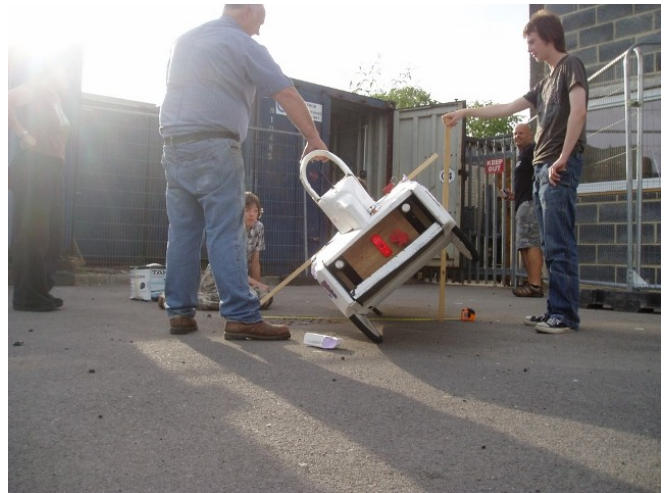
Car Rolling Angles

Rotary Racer 8e has a relatively low CofG and although not high, a reasonable wheel track for Greenpower cars of 600mm. We measured the rolling angle of the car to test its rolling stability.

The angle at the balance point was 43 degrees. We also measured the weight on the front and rear tyres and tested the sideways tyre friction on tarmac. These were:

Thus the car's static stability is such that it should slide before it rolls with a margin of: 21%

Although these figures are calculated for the static case, and on a different surface to the hairpin corner in question, the results appear to match the conjecture above, that the car was sliding when it hit a bump which caused a dynamically greater sideways force enough to tip it over. Obviously any vehicle sliding sideways and hitting an object with enough force will roll.

The above changes will increase the cars tilt angle to about 47 degrees. The cars stability would then be such that it would slide before rolling with a margin of about: 37%.
