Rotary Racer's Roll

Castle Combe – 2010-06-27

The Rotary Racer Team

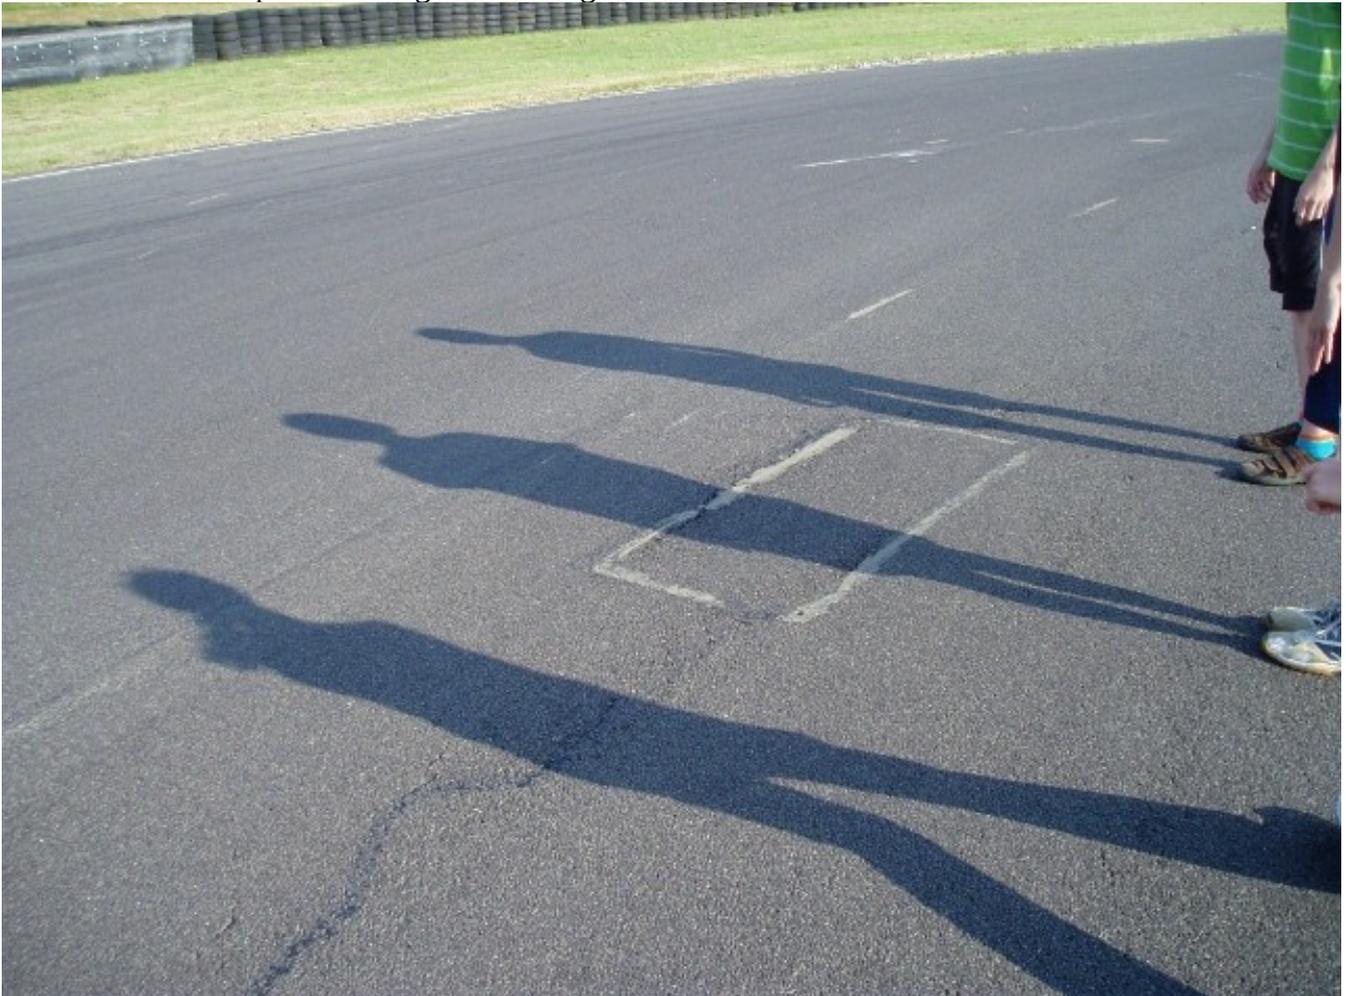
- From a report by Steve King, who was one of the marshals who picked up the car afterwards, and after looking at the track at the end of the day, there is a patch (about 1m x 0.5m) in the tarmac with some rough edges. Around it are with some gouges out of the track. This is followed by a ridge of about 3cm high for about a meter or more long, in the tarmac further to the outside of the corner probably caused by the tarmac being pushed up by full sized cars cornering hard. This is just before the marks on the ground caused by the paint on the foam sides and the roll-bar hitting and in line with the most probable line the car took. It looks like

- We think the car was cornering hard and the rear end was sliding a touch when it hit the ridge. We think that this lifted the rear end slightly off the ground, allowing the car to rotate, possibly with the brakes on. When the car dropped down the wheel would have increased sideways friction. We think this gave enough sideways force for the car to topple. Alternatively hitting the ridge may have caused the problem, but the driver did say that the car bumped up and down on the rear end before starting to roll.

- There were no flats on the front tyres suggesting that, although the brakes were on, the front wheels had not locked up.
- We believe the car rolled twice before sliding to a halt. The roll-bar protected the driver admirably and the foam sides probably softened the landing and the friction probably brought the car to a halt relatively quickly.

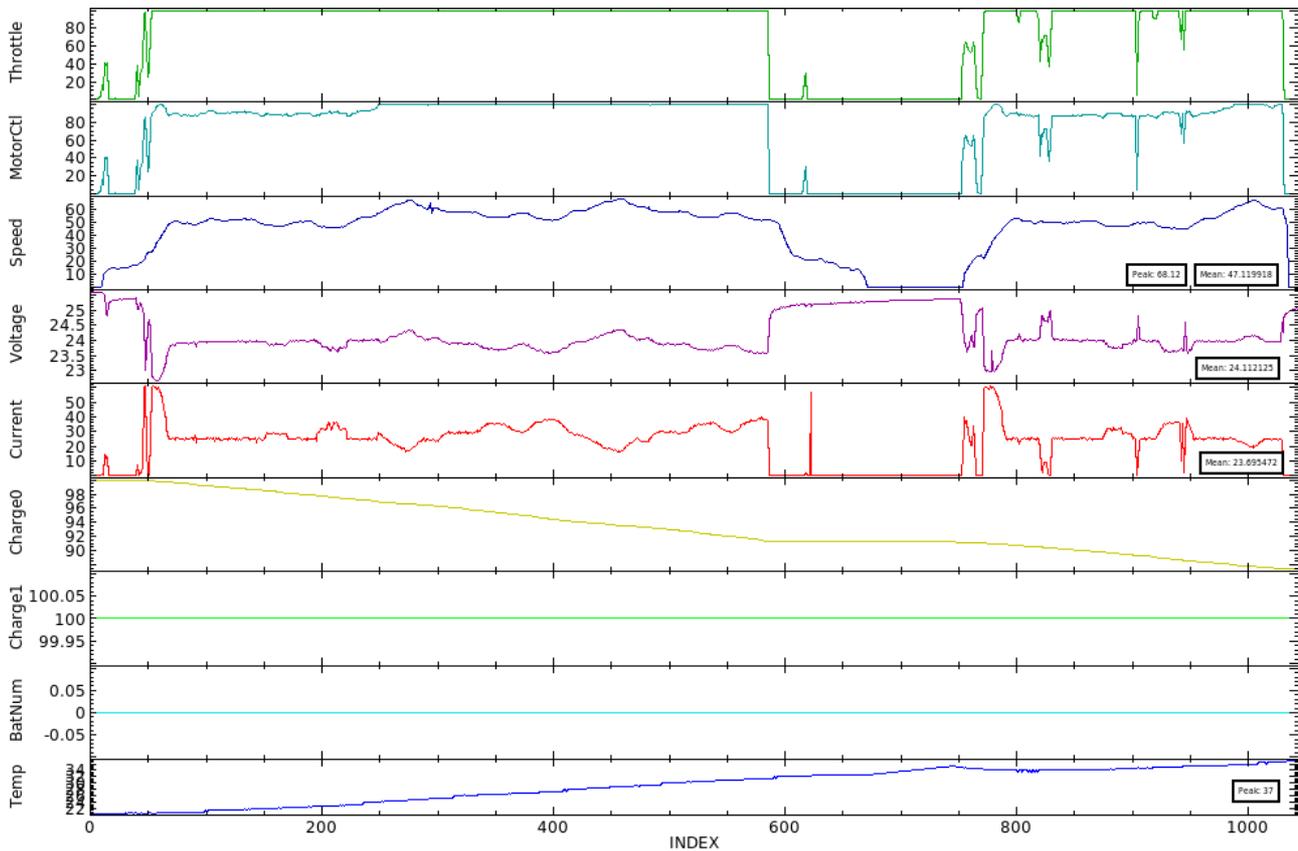
- The car was going reasonably fast, but not excessively so, at about 36.9MPH after the downhill section of the track with the wind behind. The car slowed down as it travelled up the hill towards Quarry corner and then started cornering. From the data logs it looks like the driver started to slow the car down further, with the brakes, in the last few seconds and it appears to have rolled while doing between 27.8MPH and 32.5MPH. The car had gone through this section with a previous driver at 36MPH and 37.7MPH previously on the day while on full power. However, this is quite fast for the sharp corner, a good racing line would be needed.

The car was logging data during the practice runs. This includes: Throttle position, Motor power level, Speed, Voltage, Current, GPS position etc. The data for this is at:

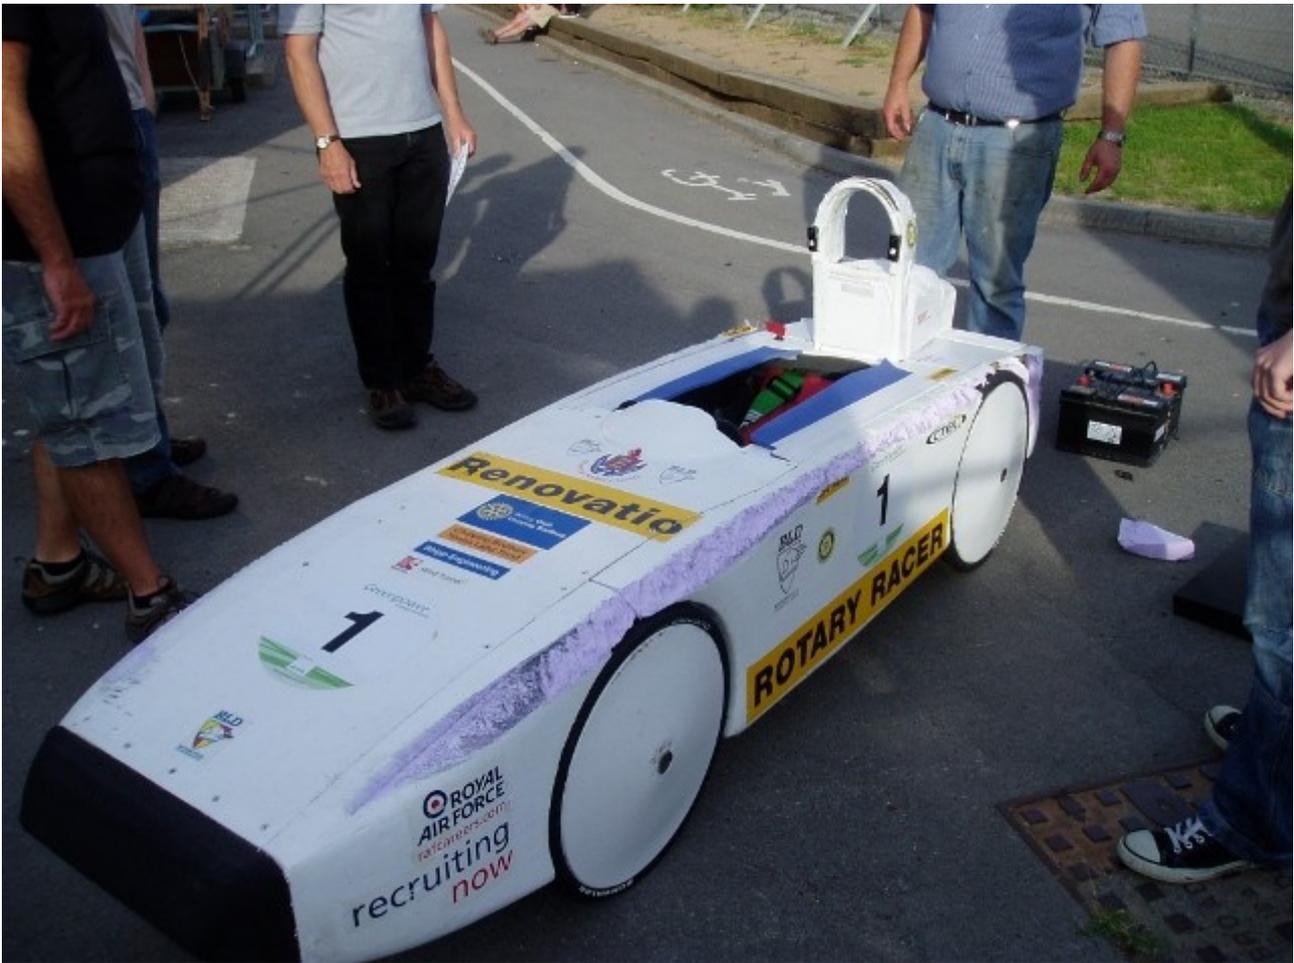
- The roll-bar was completely intact and fully upright. It had bent “forward” about an inch at the top, the car must have gone backwards for a bit, was bend slightly to one side and had deep scoring on the top edge where it had hit and rubbed the ground. The roll-bar was made of 25.4mm steel tubing, 1.6mm thick. It had a horizontal, welded steel tube brace about 190mm from the top. It was mounted to the cars steel sub-frame at the bottom by welded spigots and with 8mm steel bolts about 150mm up from this. It had an aluminium rear strut going to the rear chassis. This was fastened to the roll-bar with bolted plastic bungs one of which had popped out with the roll-bar going forward.

- The right-hand side rear wheel had bucked badly. We are pretty sure this happened during the roll rather than before. There are no broken spokes and the hubs are intact. The rim is bent. The wheels are quite strong and other than the buckle in the rim look fine. This wheel is the free running, not motor driven, wheel and was the wheel on the inside of the corner.

- The tyres, Schwalbe Durano's, were in good condition. They have done about 500 miles or so, but had no flat spots or other damage. There are some sideways scuff marks on the rear tyres after this race, but they were still fully inflated (about 110 PSI) and generally un-damaged apart from some scuffing.

- The top corners of the cars foam sides are worn away. We think this would have softened the roll and brought the car to a timely stop due to the friction with the road surface.

- The batteries did not move and there were no leaks. The plywood battery leakage box was slightly damaged around one of its holding screws, but otherwise there were no problems here.

1. We will replace the 20 inch wheels with 16 inch wheels. This will lower the cars centre of gravity by about 30mm and improve roll stability by about 12%.
2. We will make the dish in the wheels flatter. This will increase the track of the wheels by about 20mm (3%).
3. We will replace the roll-bar with an identical remade one, as it has been used.
4. We will change the rear strut to be able to take both push and pull forces.
5. We will spend more time with the drivers going over the circuits and its corners before races.
6. We intend to take the drivers on a go-kart circuit to better hone their drivers skills.

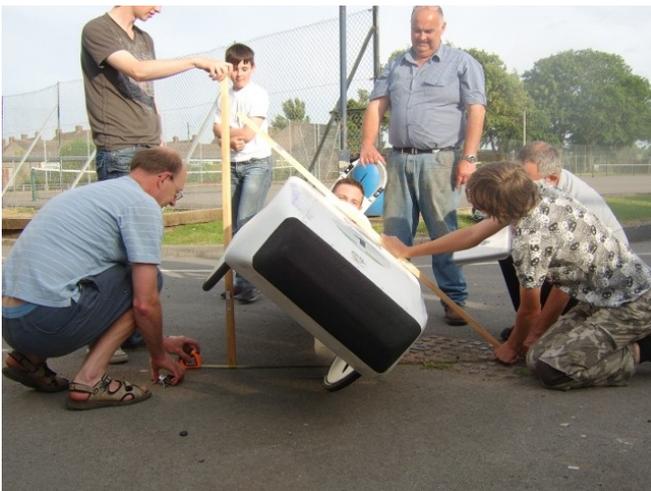
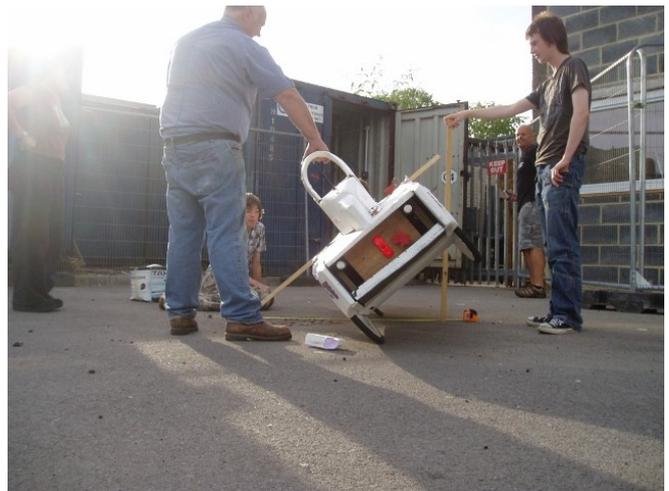
Car Rolling Angles

Rotary Racer 8e has a relatively low CofG and although not high, a reasonable wheel track for Greenpower cars of 600mm. We measured the rolling angle of the car to test its rolling stability.

The angle at the balance point was 43 degrees. We also measured the weight on the front and rear tyres and tested the sideways tyre friction on tarmac. These were:

The sideways force needed to roll the car is thus about: $135\text{Kg} = (145 * \tan(43))$

The car will slide when the force is: 110Kg

Thus the car's static stability is such that it should slide before it rolls with a margin of: 21%

Although these figures are calculated for the static case, and on a different surface to the hairpin corner in question, the results appear to match the conjecture above, that the car was sliding when it hit a bump which caused a dynamically greater sideways force enough to tip it over. Obviously any vehicle sliding sideways and hitting an object with enough force will roll.

The above changes will increase the cars tilt angle to about 47 degrees. The cars stability would then be such that it would slide before rolling with a margin of about: 37%.
