GpSpeed MOSFET Insulating Washer Issue

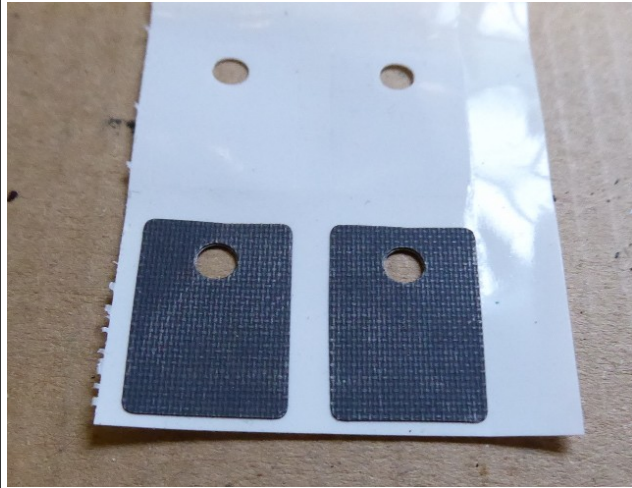
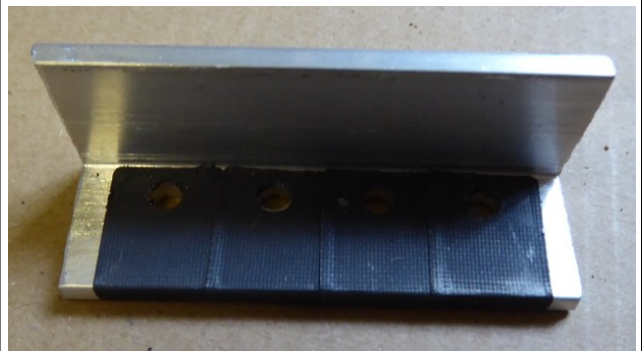
While investigating some issues with a schools GpSpeed controllers, it has come to my attention that there is an issue with the MOSFET insulating pads that some GpSpeed kits were shipped with. Some GpSpeeds have been shipped with white/beige coloured pads and some with black pads as shown below.

The white/beige pads are fine, but the black pads are not fully electrically insulating and can, if the screws are tightened hard (as they should be) cause the MOSFET's/heat-sink to heat up as current will flow through them. Also any burrs at all are likely to cause shorts from the MOSFET to the heat-sink.

If you have these black ones on your GpSpeed controller, I strongly recommend replacing the pads with RS stock number 707-3361 or 169-2177. If you like I can send some to you, just email me with you address and how many you need.

To fix:

1. Unbolt all of the MOSFET's.
2. Gently lever the MOSFET's a mm or so above the bracket.
3. Pull the bracket out.
4. Clean off the old black pads. They are stuck on. A plastic scraper, like an old credit card, works well followed by some electrical cleaning fluid or spirit.

5. Make sure the MOSFET mount holes are de-burred and holes clear. Hand spinning a 6mm drill in the holes will clear off the burr and slightly chamfer the hole edges. A 3.5mm drill can be used to clean them out. Finish with fine memory cloth or sandpaper and clean with a rag and spirit including the holes.
6. Refit the bracket with the new pads underneath and bolt in the MOSFET's using the bolts and bushes.
7. The bracket should be isolated from the MOSFET tabs and the bolts, check with an Ohm meter.
8. The MOSFET's bolts should be reasonably tight. It is worth re-tightening them after they have had time to settle.

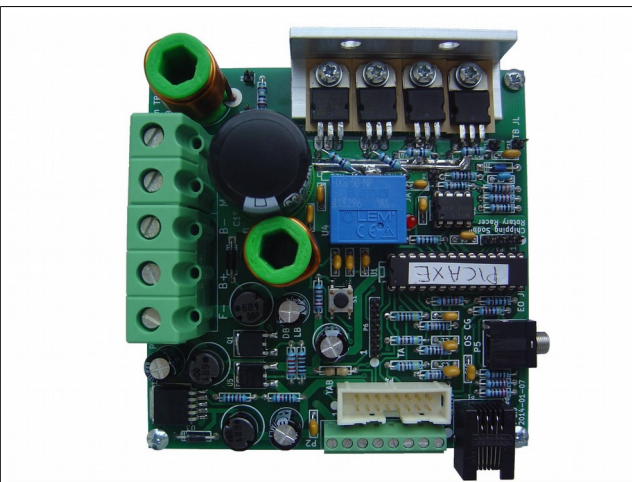
This picture shows a GpSpeed with the white/beige pads. This is fine.
